## The Condition of St. Paul's Cathedral

# Committee Appointed by the Dean and Chapter.

August, 1907.

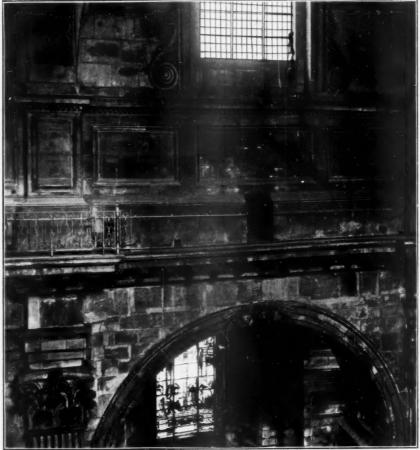
The photographs 8 show some of the cracks to which Mr. Clarke drew attention, and in proof of the early origin of the trouble, we may give a single illustration from the building itself. The clerestory windows nearest to the dome, those of choir and nave as well as those of the quarter domes are much distorted. The sills all slope in the direction of the dome itself, and have been levelled up. Above these windows the whole wall has followed the same inclination, and just below the cornice wedge-shaped courses of stone have been inserted, the flat ends towards the dome and the thin ends east and west, &c., to enable the cornice to run through. These wedge-shaped pieces may be seen on the north, as well as on the south side of the church. From this it is evident that a settlement was early at work, in spite of Wren's plans for spreading the enormous weight of the dome over as wide an area as possible; the repairs are recorded, and before the height of the cornice was reached a space of several inches had to be made up to the level.

PHOTOGRAPHS SHOWING SINKING OF CORNICE AND CRACKS IN EAST CLERESTORY WALL OF SOUTH TRANSEPT.

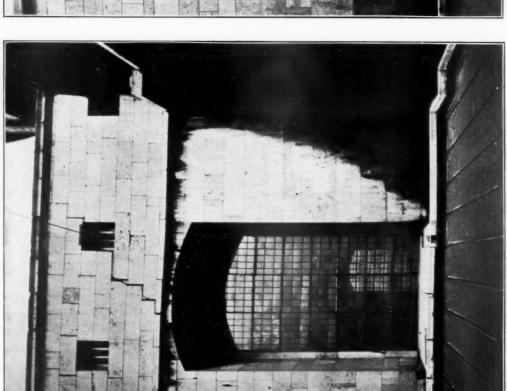
West Clerestory Wall of North Transept, from roof of West Aisle of North Transept. June 1907.

CRACKS AND SINKINGS IN THE EXTERIOR TRANSEPT WALLS.

West Aisle of North Transept. East Clerestory Wall of South Transept, from roof of East Aisle of South Transept.

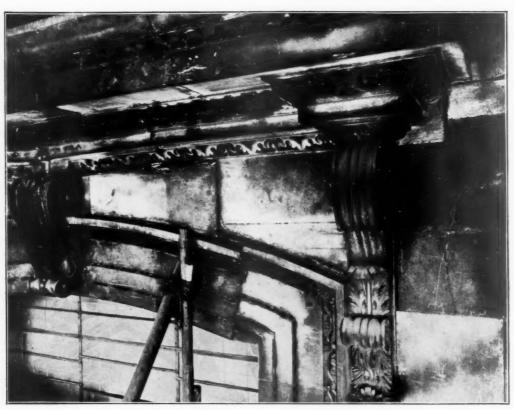
FIG. 4.

The west wall of the church, or back of the portico, which is pierced by the great doorway and window above it, has split in half from the top to the bottom. The horizontal door-head gives but slight indication of the movement, but the window-head above has suffered seriously, as shown by the photographs (Figs. 4, 5, and 6).

Figs. 4 and 6 show how considerable have been the dislocations consequent on the west wall of the

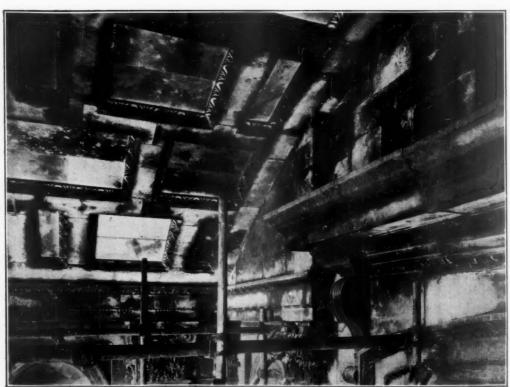
FIG. 5.

The portico of the west front, rising as it does in two stories, is covered at each level with a coffered vault of Portland stone, about fifty feet in span, but not rising above the springing line more than some eight feet (see Fig. 5). There are thus two very flat vaults sustained by thrusts against the structures north and south of them. As might be expected, the upper vault has shown very much greater signs of dislocation and movement than the lower. Whilst the lower springs at a level of some forty feet from the church floor, the upper springs at a level of about eighty feet. Whilst the lower vault is to some degree steadied by the brick walls which lie on the back and carry the pavement of the upper portico, the vault of the upper portico has only to carry itself, and is in no way steadied by any superincumbent weight. The photograph (Fig. 5) gives but a slight idea of the dislocation that has taken place. As these vaults stand quite independently of the walls at their sides, and form an integral part of the structure at the springing line only, the stones of which they are formed-of about eighteen inches in thickness, with coffers sunk out of that thickness-were free to move, and had taken great advantage of the freedom. Walking over the back of the upper vault one could see through the crack between it and the back of the pediment. The stones had moved, some settling on the line of the long axis of the curve, but others in a far more perilous way had settled on the transverse line. A rule could be pushed between many of the stones, whilst at the joints the soffit of one would be more than two inches below that of another, the voussoirs being held in place by pinching at the extrados and not at the intrados. This, of course, shows that unintended thrusts were being exerted against the back of the pediment on the west and the wall over the west
